SPECIAL AIRWORTHINESS INFORMATION BULLETIN

CE-05-07
October 22, 2004

AIRWORTHINESS ALERT

SZD-50-3 PUCHACZ

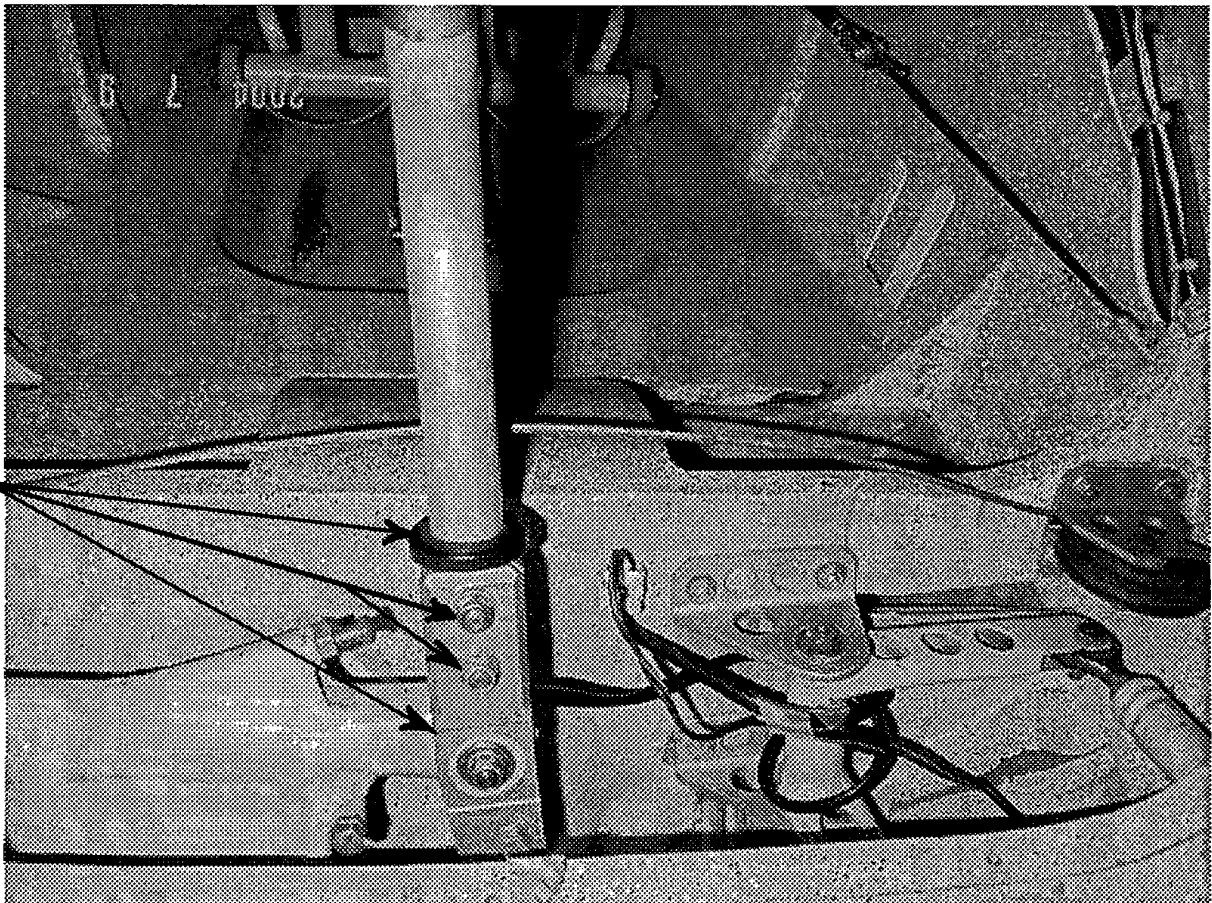
POTENTIAL CRACK SITES

A report has been received from Poland where last week-end a Puchacz suffered a complete failure of the front control column. At this stage the precise details of the failure or the outcome of the incident are not known but it is believed to be a fatigue related failure. It is known that the aircraft had only done approx 1500 hours and the Poles have grounded their Puchacz fleet pending an inspection of the front control column. Prudence suggests we should do likewise.

5. Undo both nuts and tap out bolts with a soft drift.
6. Remove parts and examine control column in area around bolt holes and where it emerges from the aluminium parts just removed. Also check the front and rear halves of the fork. Use a magnifying glass of at least 3X power, preferably 5X. Dye penetrant method may also be used. (shield the bearings when spraying the fork halves!)

1. Before further flight, inspect the aircraft for cracks in the area shown on the attached drawing. Be imaginative, as we are not sure yet which part actually failed.
2. Ground the aircraft, pending rectification, if cracks are found.
3. Notify results of inspections to GFA without delay (whether cracks found or not).
4. Inspection to be performed by or under the supervision of a person holding a current GFA Airworthiness Authority endorsed for Inspection for issue of a Maintenance Release or higher.

7. If any cracks are found the aircraft is to be withdrawn from service until replacement parts have been fitted. If no cracks are found the aircraft may be returned to service.

8. Replace parts, taking care to assemble in the original order, dress any imperfections before refitting as necessary.
9. The findings of this inspection are to be recorded in the aircraft logbook and also reported to the GFA whether cracks were found or not. Ring the Airworthiness office on (03) 9379-7411, Fax (03)9379-5519 or e-mail stoa@gfa.org.au
